**Installation Restoration Program
Phase II — Confirmation/Quantification
Stage 1**

**Dover Air Force Base
Dover, Delaware 19901**

*Science Applications International Corporation
8400 Westpark Drive, McLean, VA 22102*

**Final Report 9/84 to 6/86
Volume 1 — Technical Report**

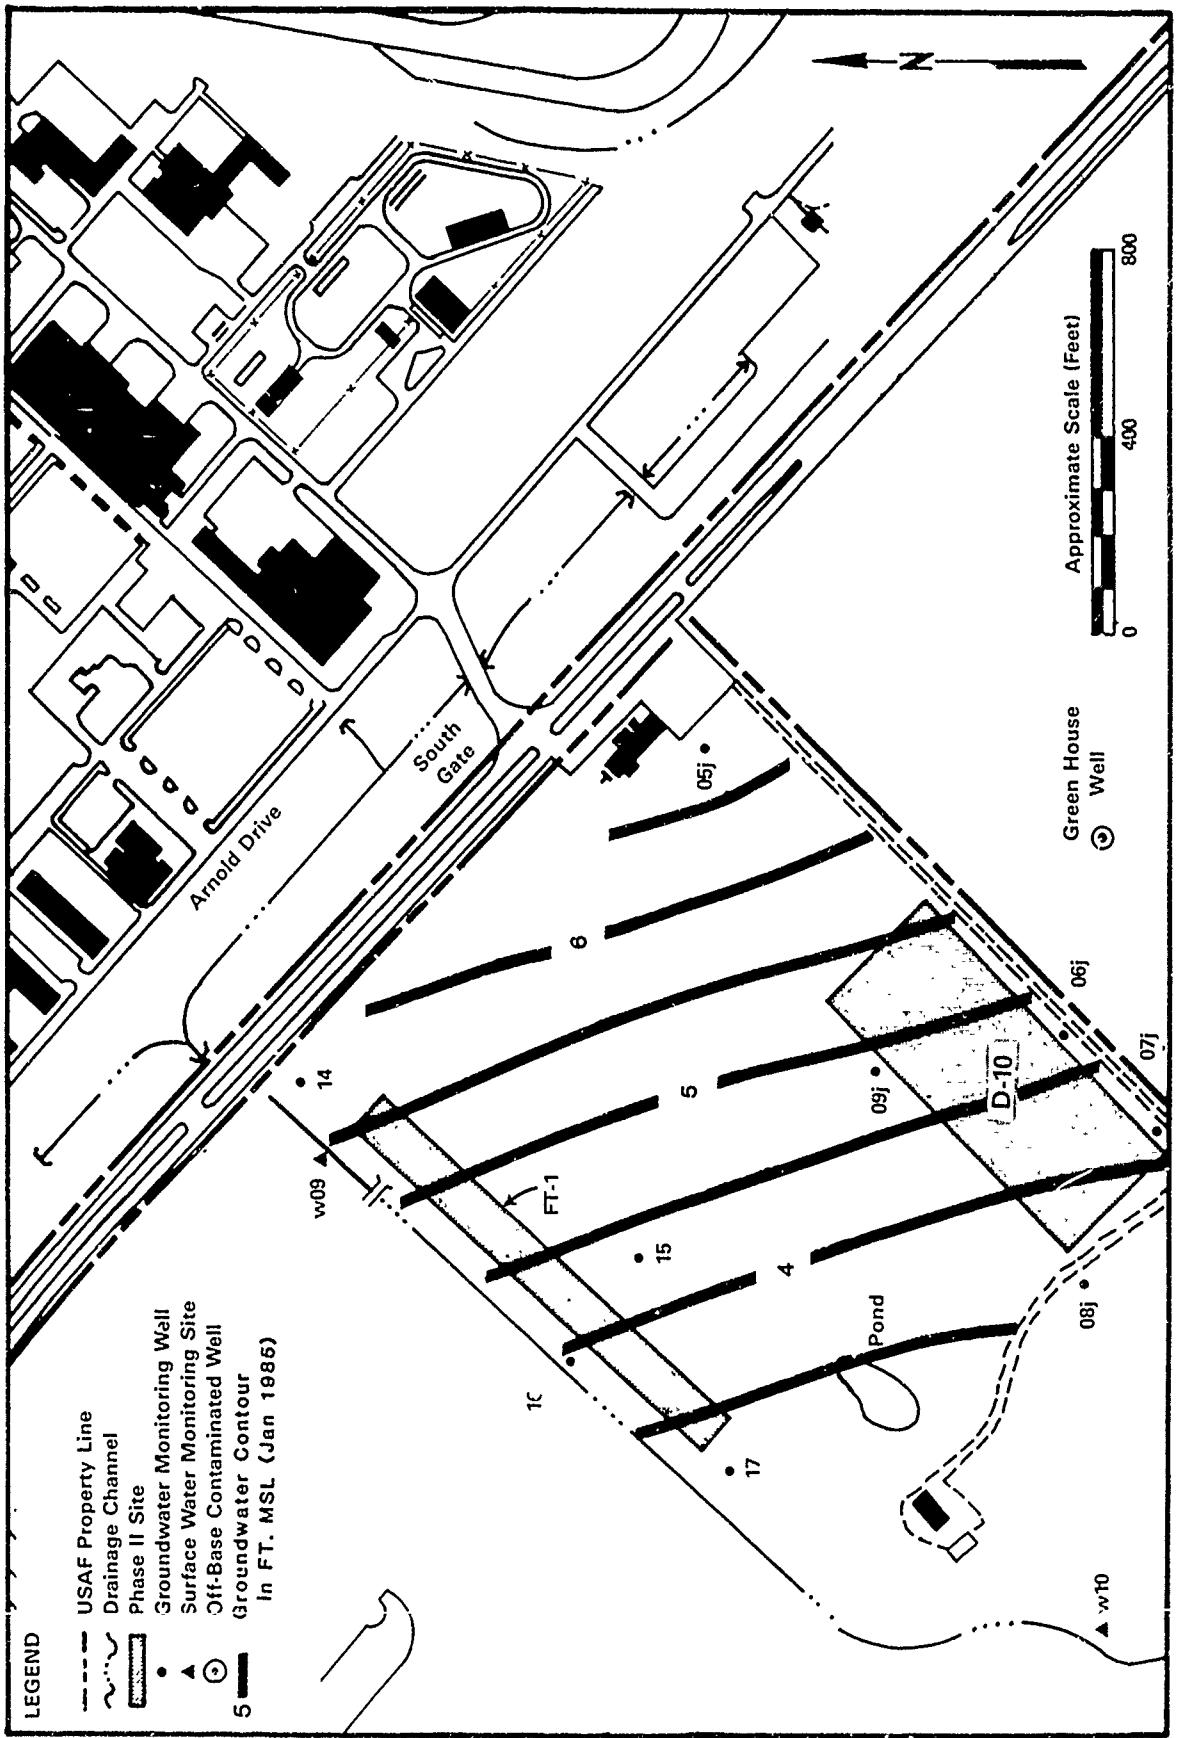
Figure 2-13. Golf Course Sites, D-10 and FT-1

Site D-10, Landfill is located beneath the golf course on the southwest portion of DAFB (Figure 2-13). The site was used during the 1950s for the disposal of general base refuse, spent chemicals, and industrial shop wastes. Trenches were excavated to a depth of approximately 15 feet, probably close to or into groundwater. At present, uneven ground settling possibly caused by differential subsidence of waste or drum collapse is noticeable in this area.

Site FT-1, Fire Training Area 1 covers an area of approximately 900 feet by 50 feet on the golf course east of the drainage ditch. Drums of contaminated waste oils, solvents, paint thinners, and contaminated fuels were reportedly stored on site prior to burning, plus reports indicated residual fuels and wastes remained on the ground after each training exercise. These conditions indicate a high potential for contamination. Operations at the site consisted of spreading at least 1000 gallons of waste fuels and liquids on a water saturated area, igniting the material, and using protein foams to extinguish the flames. These exercises reportedly were conducted twice per week from 1951 through 1962; however, a review of aerial photos indicated fire training operations may have ceased prior to 1959 when construction of the golf course began. At present, evidence of environmental degradation or contaminant release is not visible.

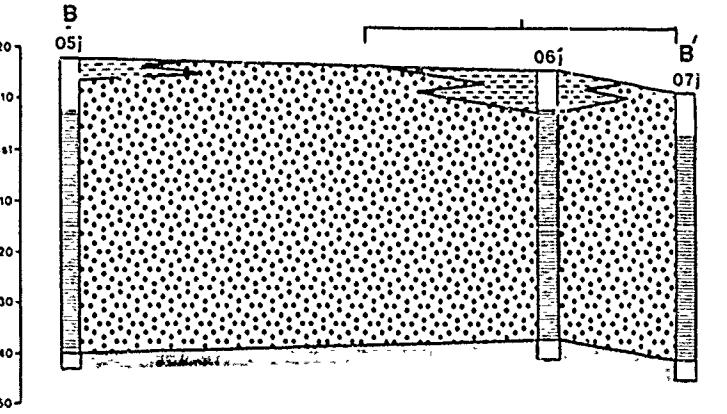
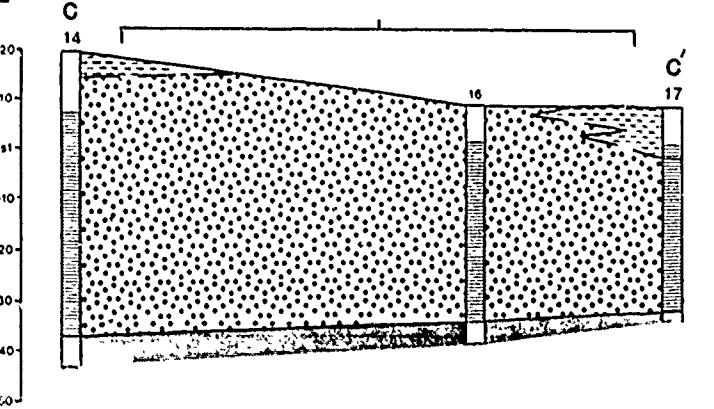
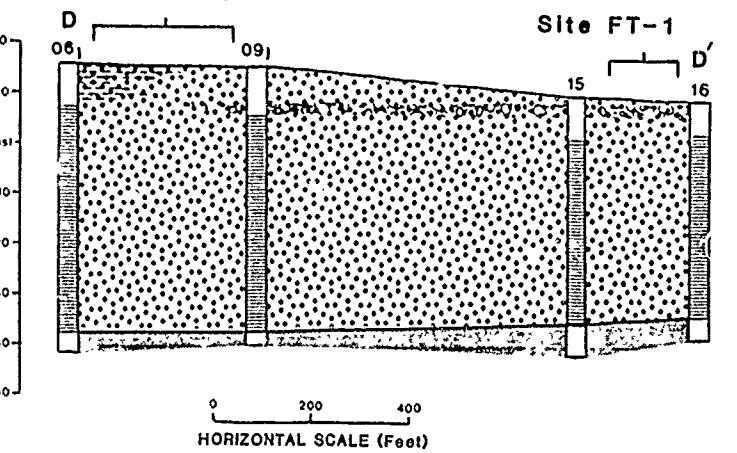
The Columbia is homogeneous beneath FT-1 (cross section C-C'). Thin silty sand lenses, similar to those of section B-B', occur in the uppermost portion of the Columbia. However, the thin gravel beds found under D-10 are not present under FT-1. The aquifer's lithology, best described as poorly sorted, medium to coarse sand, with some gravel, is essentially the same as that described in the literature. The contact between the Columbia and underlying Kirkwood (Miocene) dips to the northeast at approximately one foot vertically for every 600 feet horizontally (0.167%).

Cross section D-D' illustrates the subsurface conditions between sites D-10 and FT-1. The Columbia is primarily composed of medium to coarse sand, with a thin gravel layer occurring between three and six feet BLS. Reworking or regrading of the area may be the source for this thin gravel bed rather than Pleistocene deposition. The Kirkwood (Miocene) again appeared as a dark gray, well compacted, finely laminated, silty clay, dipping very slightly (2 feet over a distance of 1250 feet, or 0.16%) to the southeast.

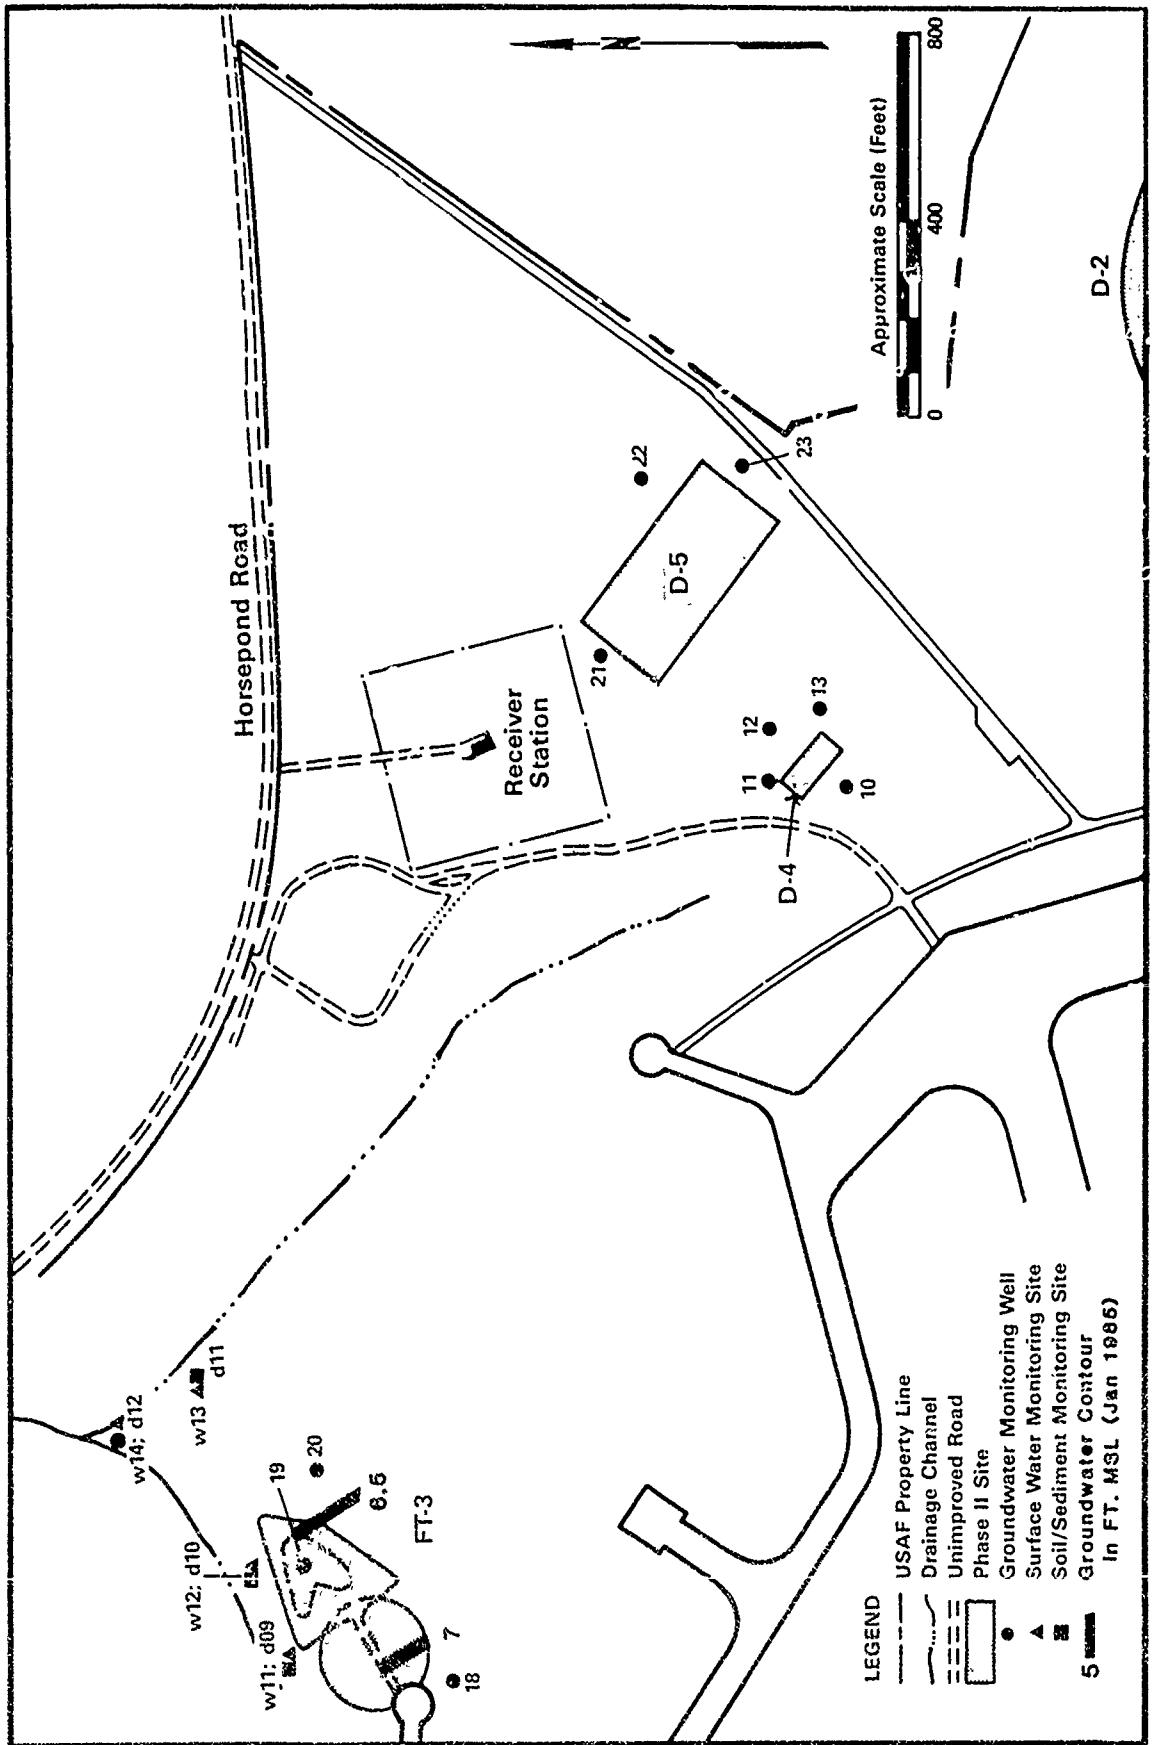
Site D-4, Liquid Waste Site is located in the northeast section of the base near the Receiver Station (Figure 2-15). Liquid industrial wastes and waste oils were disposed during the late 1950s in a single trench approximately 15 feet wide, 100 feet long, and 10 feet deep. At present, the area shows evidence of waste disposal activity, but this evidence (e.g., disturbed ground, subsidence, and dead vegetation in strips approximately 15 feet wide by 75 feet long) cannot be attributed only to D-4 because two other disposal

sites, Site D-5, Landfill and Site SD-1, Sludge Disposal area are located in the same general area. The location of D-4 was delineated by a heavy equipment operator who excavated the trenches at the site.

Site D-5 is located in the same general area as D-4 (Figure 2-15). The site was reported to be less than 0.5 acres and used in the 1960s, although personnel familiar with the site described it as much larger. The area method of filling was used and wastes were placed to a depth of 8 feet.

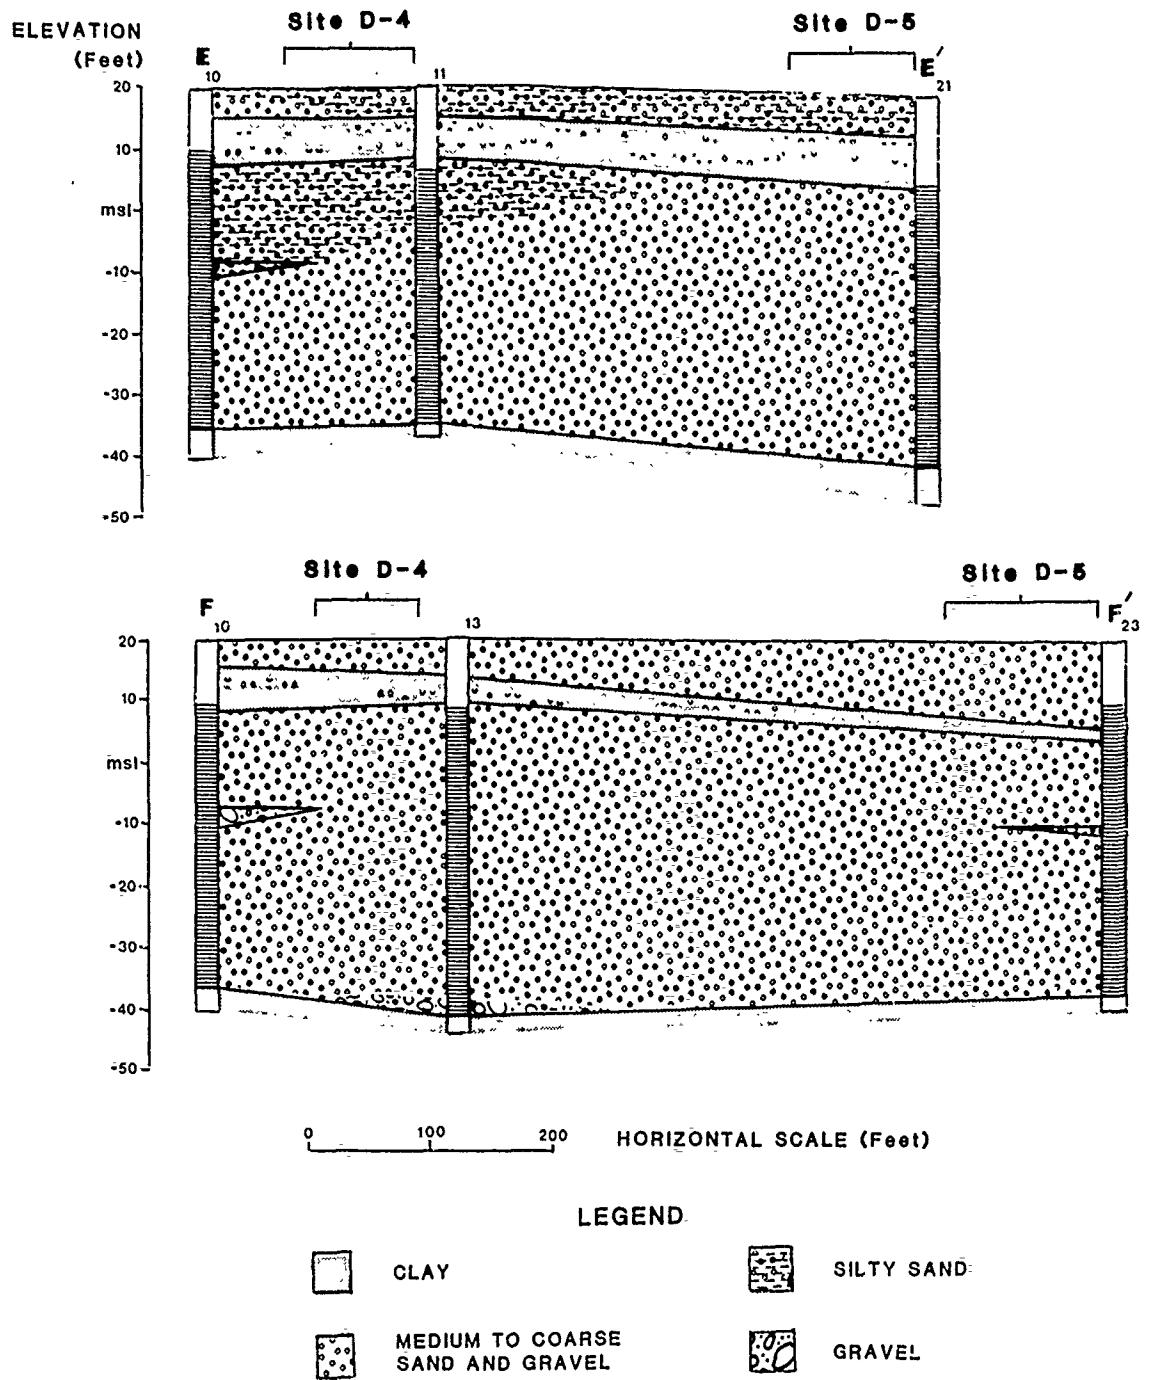
Figure 2-16. Geologic Cross-section at Sites D-4 and D-5

A total of seven monitoring wells were installed in this area. Cross sections E-E' and F-F' (Figure 2-16) extend approximately 600 and 700 feet respectively northwest and southeast of the sites. The Columbia deposits found beneath the Receiver Station Sites show much greater heterogeneity than at any other Stage 1 site. A silty clay layer occurs from 4 to 14 feet BLS and appears to be laterally continuous beneath both sites. This upper unit varies in thickness from 2 to 10 feet and is marginally thicker northwest of the sites. The unit appears to have a larger percentage of clay size materials in wells 21 and 23 at the northeast extremities of the two cross sections than found in well 10.

Beneath the upper silty clay, the Columbia aquifer gradually coarsens downward with the exception of discontinuous gravel lenses at 28 feet BLS (well 10) and 30 feet BLS (well 23). The mildly undulating contact between the Columbia and Kirkwood (Miocene) silty clay dips up to 2 degrees without preferential orientation. The Kirkwood appears as a finely laminated, dark gray, silty clay.

Groundwater elevations showed little variability between wells in the area, ranging from +8.79 ft MSL to +8.94 ft MSL. Consequently, direction of flow is not known and gradients cannot be calculated. Based on the DAFB area potentiometric surface map (Figure 2-9), groundwater is moving northwest towards the wetlands area along Pipe Elm Branch.

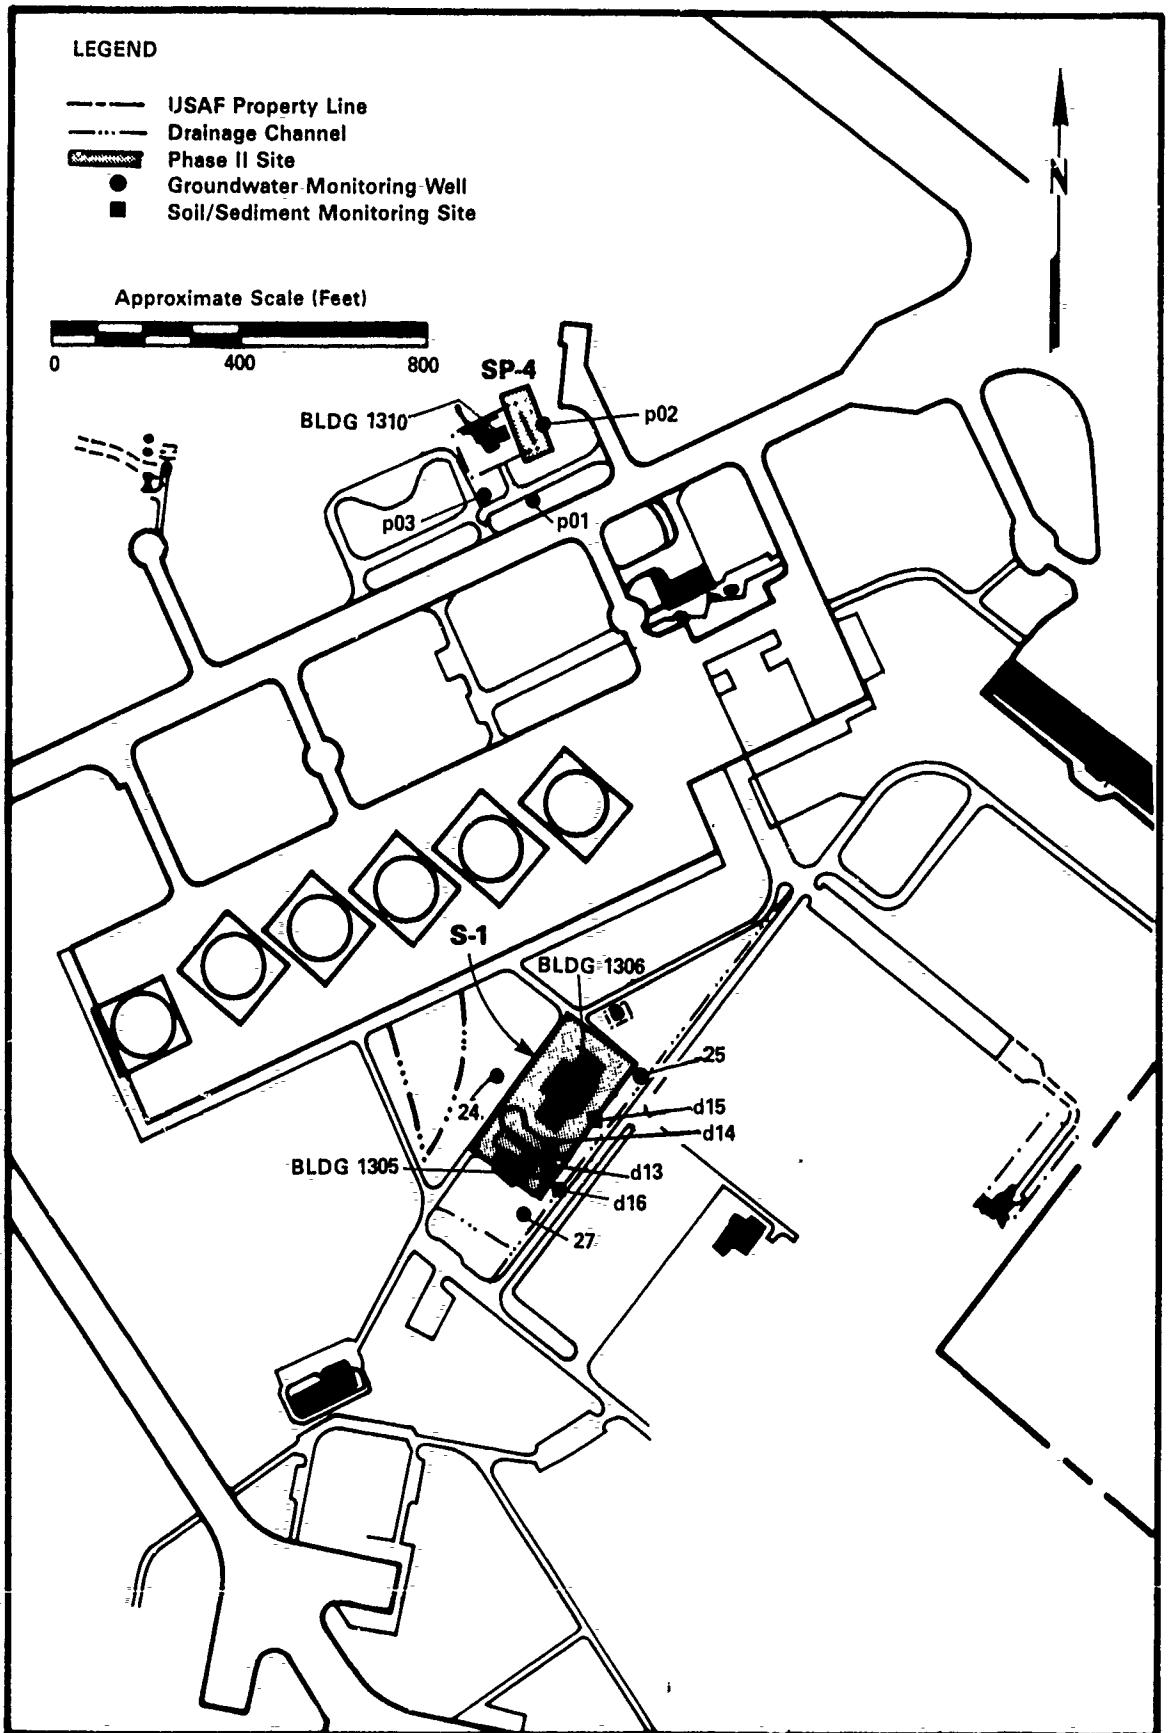
Figure 2-18. Site SP-4, JP-4 Pipeline Leak and Site S-1, Hazardous Waste Storage

Site SP-4, JP-4 Pipeline Leak northeast of Building 1310, (Figure 2-18) was identified as a potential site primarily because of the size of the spill that occurred in 1975 and the extent of cleanup could not be determined.

1. The extent of the spill was unknown and could be quite small. In addition, any residual contamination may have migrated from the site, been diluted below detection limits, or been degraded below detection limits.
2. The spill site was located close to a groundwater divide. Consequently, residual contaminants may be moving away from the spill site in more than one direction.

Site S-1 is located at Buildings 1306 and 1305 in the southeastern section of the base (Figure 2-18). Drummed waste from industrial shops are stored in these areas until contracts are arranged for off-base disposal. The yard is lined with an asphalt pavement. Visual evidence of contamination was not found during the Phase II presurvey site visit.

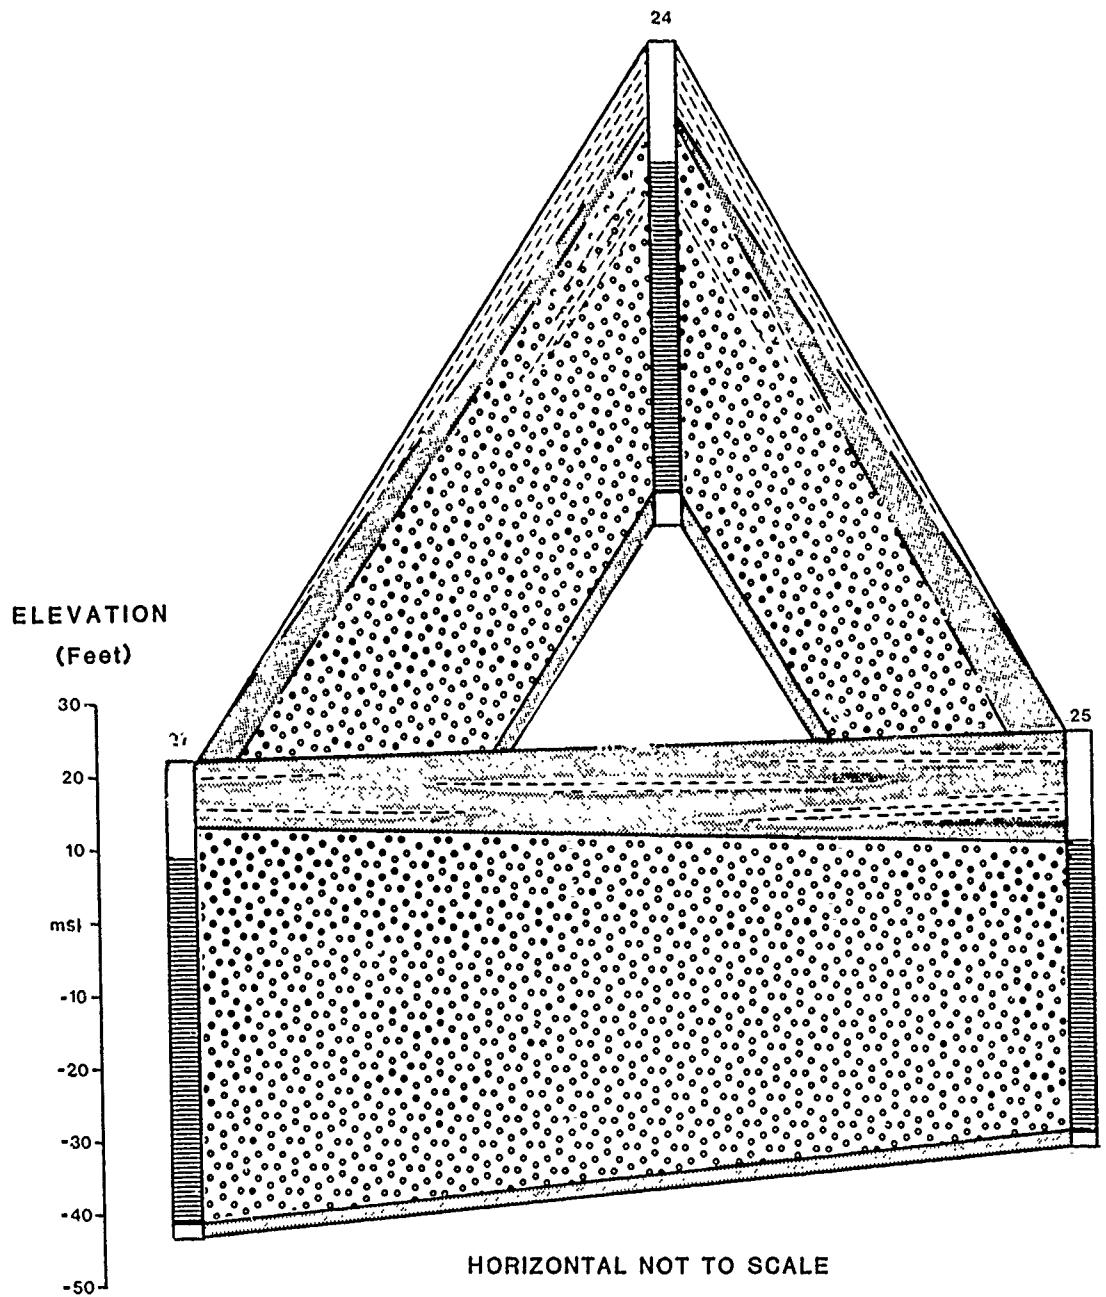
Figure 2-19. Fence Diagram for Site S-1

Generally the composition of the Columbia coarsens downward. The upper portion consists of a sequence of silts and silty clays ranging in thickness from 9 feet in well 27 to 15 feet in well 25, which grade laterally to silty sands with a thin clay interbed in the upper 24 feet of well 24. Below this horizon the Columbia is principally medium to coarse sand and gravel. The contact between the Columbia and the underlying Kirkwood (Miocene) is sharp and was found at an elevation 11 feet higher in well 25 than in well 27. This represents the greatest relief identified during Stage 1. The apparent dip of the Kirkwood is slightly greater than 3 percent in a southwest direction.

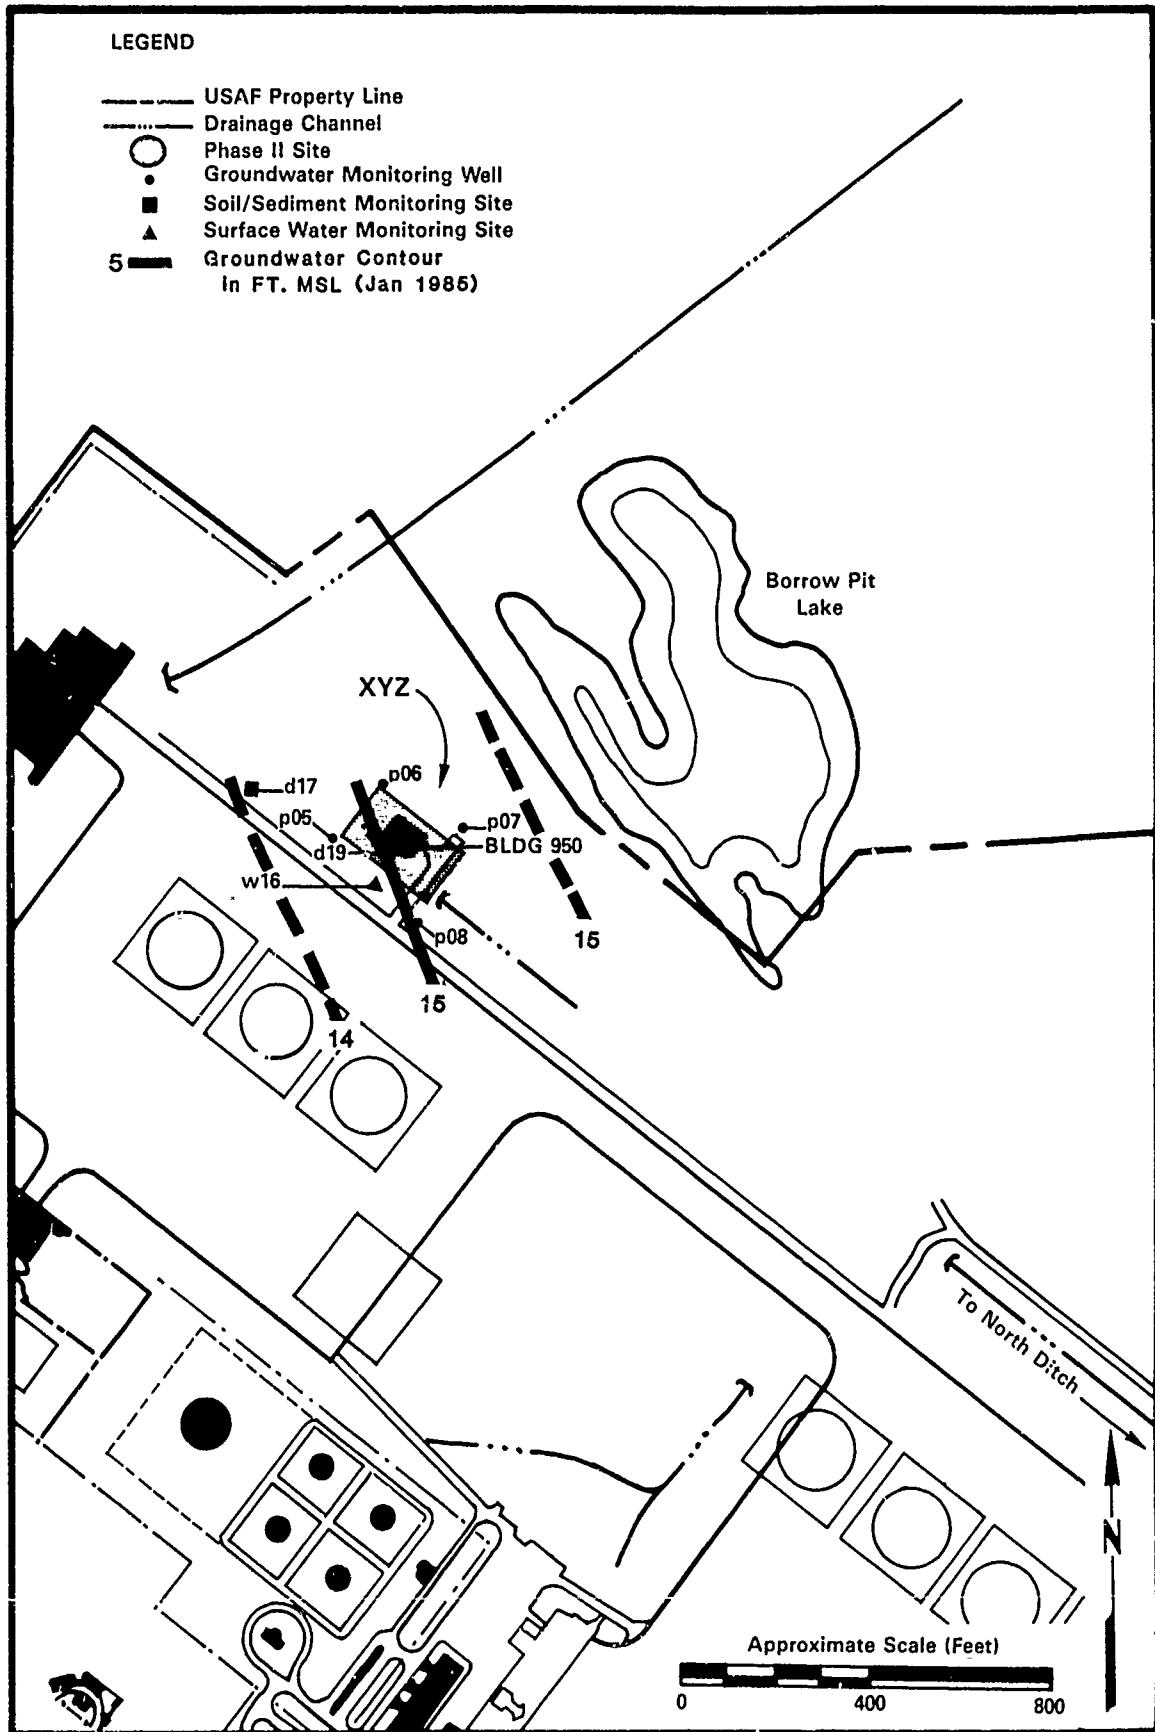
Figure 2-20. Site XYZ, Fuel Pump Station

This site was identified during the Phase II presurvey site visit. DAFB personnel reported that rainwater in manholes along the hardstand in the area of Building 950 (Figure 2-20) contained a distinct fuel layer on top of the water. DAFB personnel recalled a spill of fuel in this area. Alternately, the fuel could be the result of residual fuels from the hardstand being carried into the manholes by runoff or could be the result of spilled fuel floating on top of the groundwater and entering the manholes when the water table rose.

Cuttings obtained during the installation of four well points showed Site XYZ to be underlain by poorly sorted materials ranging in grain size from clay to gravel, but principally consisting of fine to coarse sands. Depth of the well points ranged from 15.0 to 20.5 feet BLS, with the entire interval best described as silty sand with a trace of clay, grading downward to medium to coarse sand with some gravel. Groundwater flow is southwest towards the St. Jones River (Figure 2-20) and apparently not towards the Borrow Pit Lake northeast of the site. Maximum hydraulic gradient in the area is approximately 0.45 percent. Groundwater velocity was calculated to be 2.0 feet/day, and travel time to the base boundary was estimated to be 3.55 years. Calculations are provided in Appendix K.

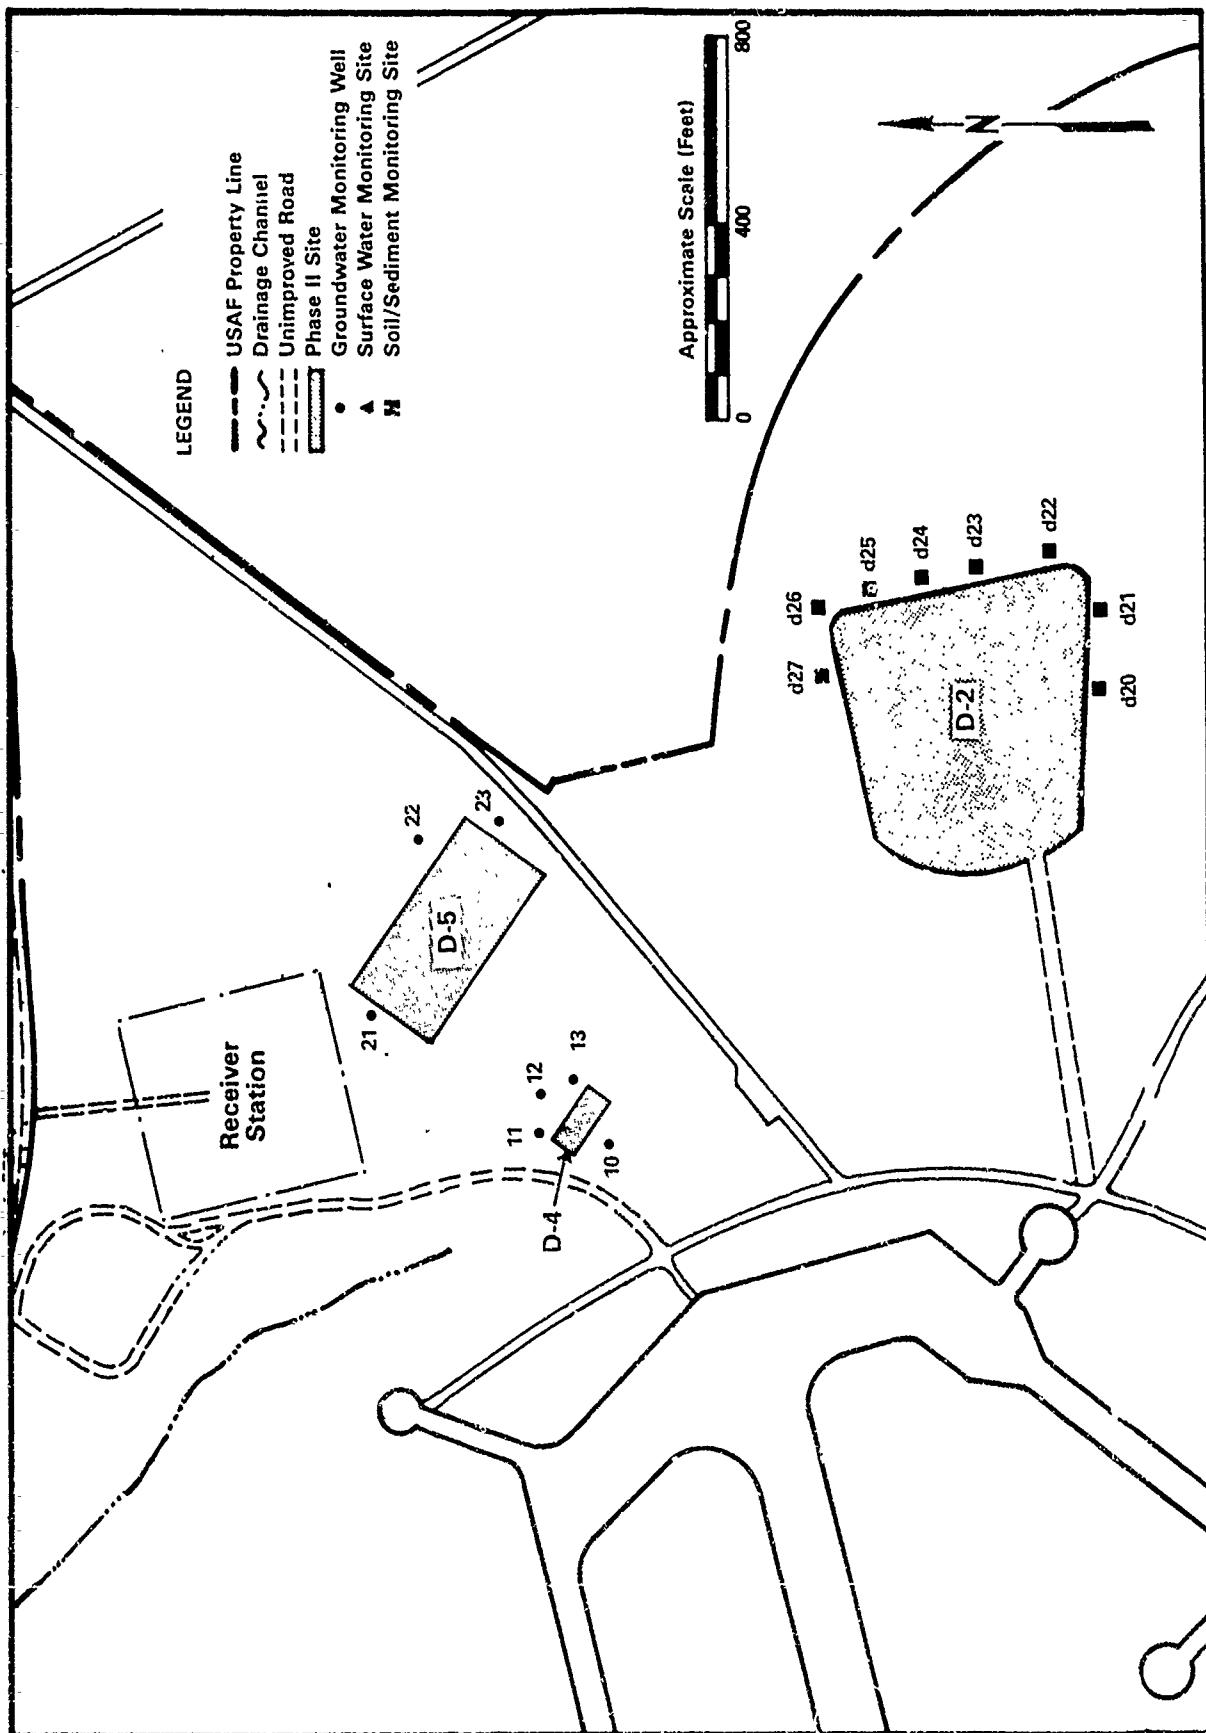
Figure 2-21. Site D-2, Rubble Area.

Site D-2, Rubble Area is the largest disposal site on base and currently is being used for the disposal of construction debris and rubble. The site is located in the eastern portion of the base (Figure 2-21) and the surface is covered with concrete, lumber, cans, metal scraps, and other debris. The eastern edge of the site is a level area which abruptly ends in a 20-foot ~~lr.~~ that consists of concrete and debris. The low area extends from the fill's toe to a treeline close to the base boundary. This low area is also covered with debris and rubble.

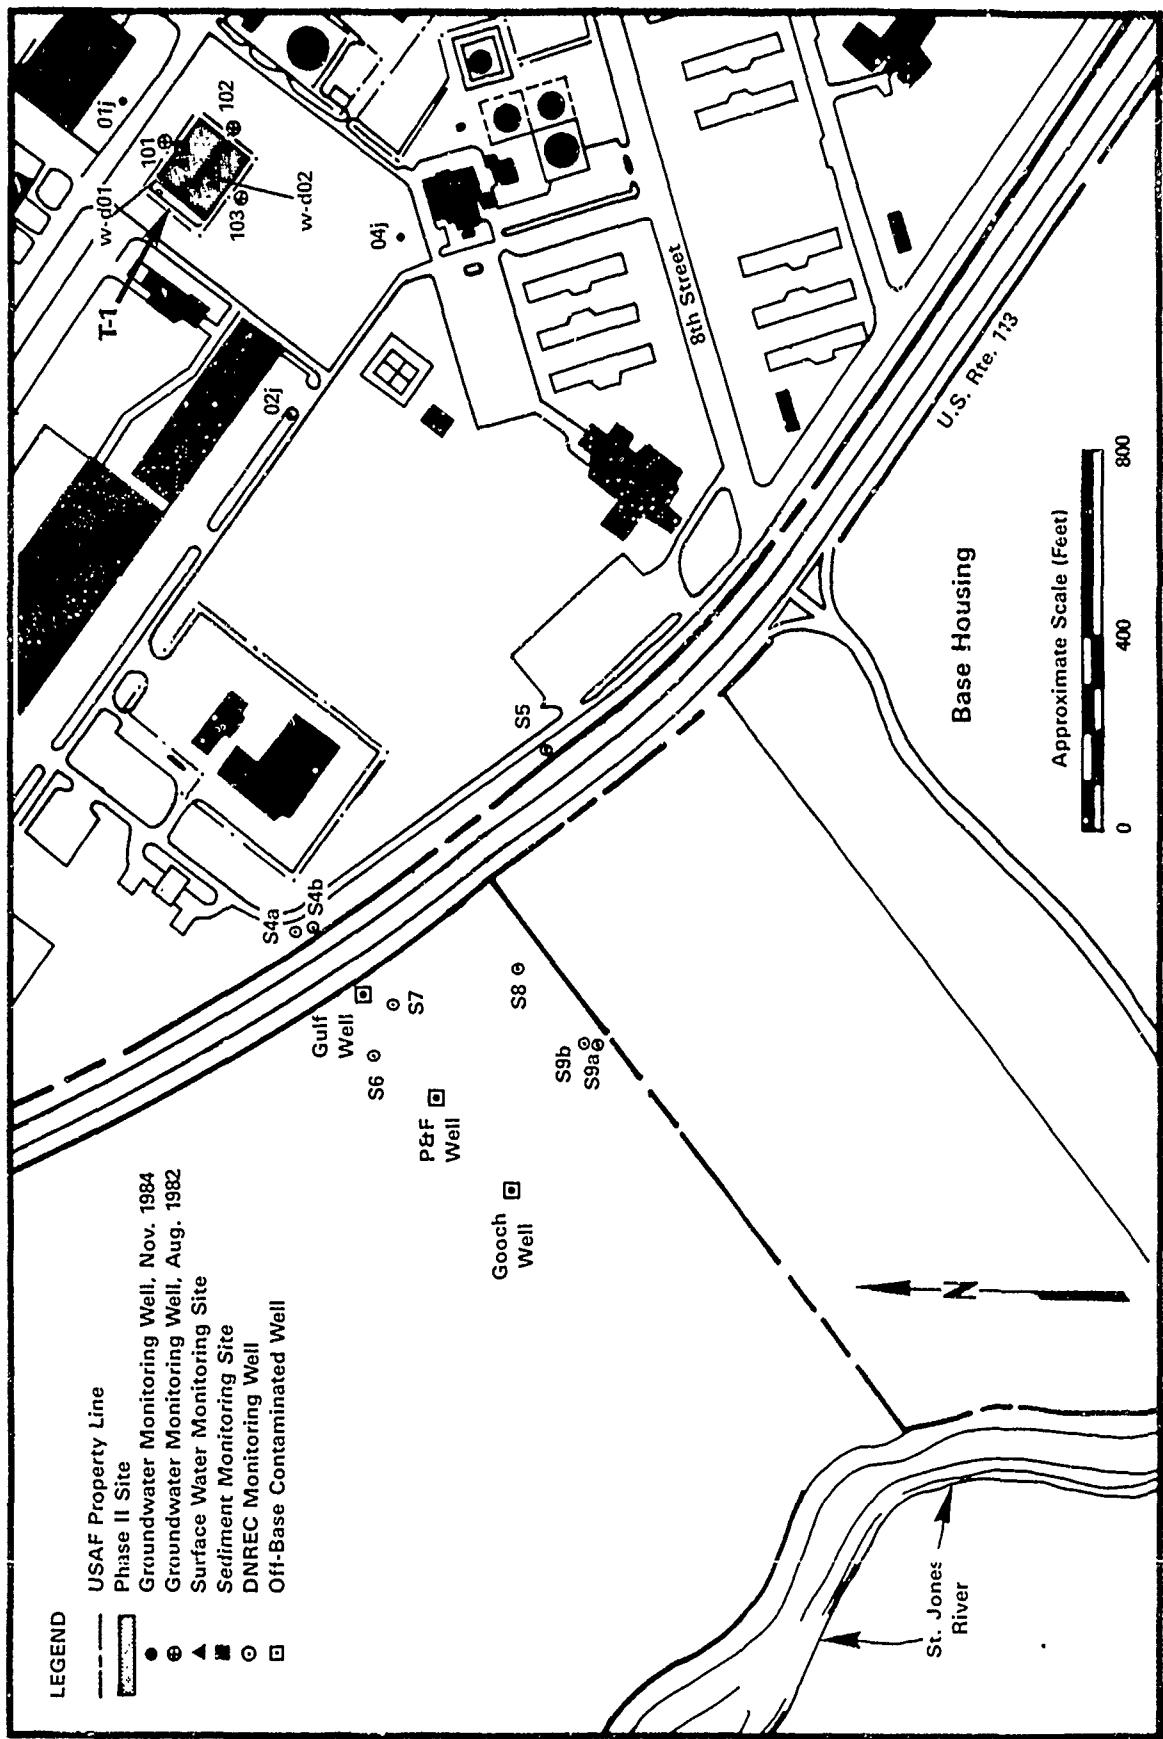
Figure 4-1. Monitoring Locations: Site T-1, 1W Basins

Groundwater samples were collected from the six wells at Site T-1, as shown in Figure 4-1. Wells 101, 102, and 103 were installed in 1982 and are located next to the lagoons. These wells do not fully penetrate the Columbia aquifer. Well 01j was installed during Stage 1 as the upgradient well for the site. Wells 02j and 04j were also installed during Stage 1 to determine groundwater quality downgradient of the basin along suspected migration paths. Well 02j was located in a direct line between the basins and the contaminated wells across Route 113 from DAFB.

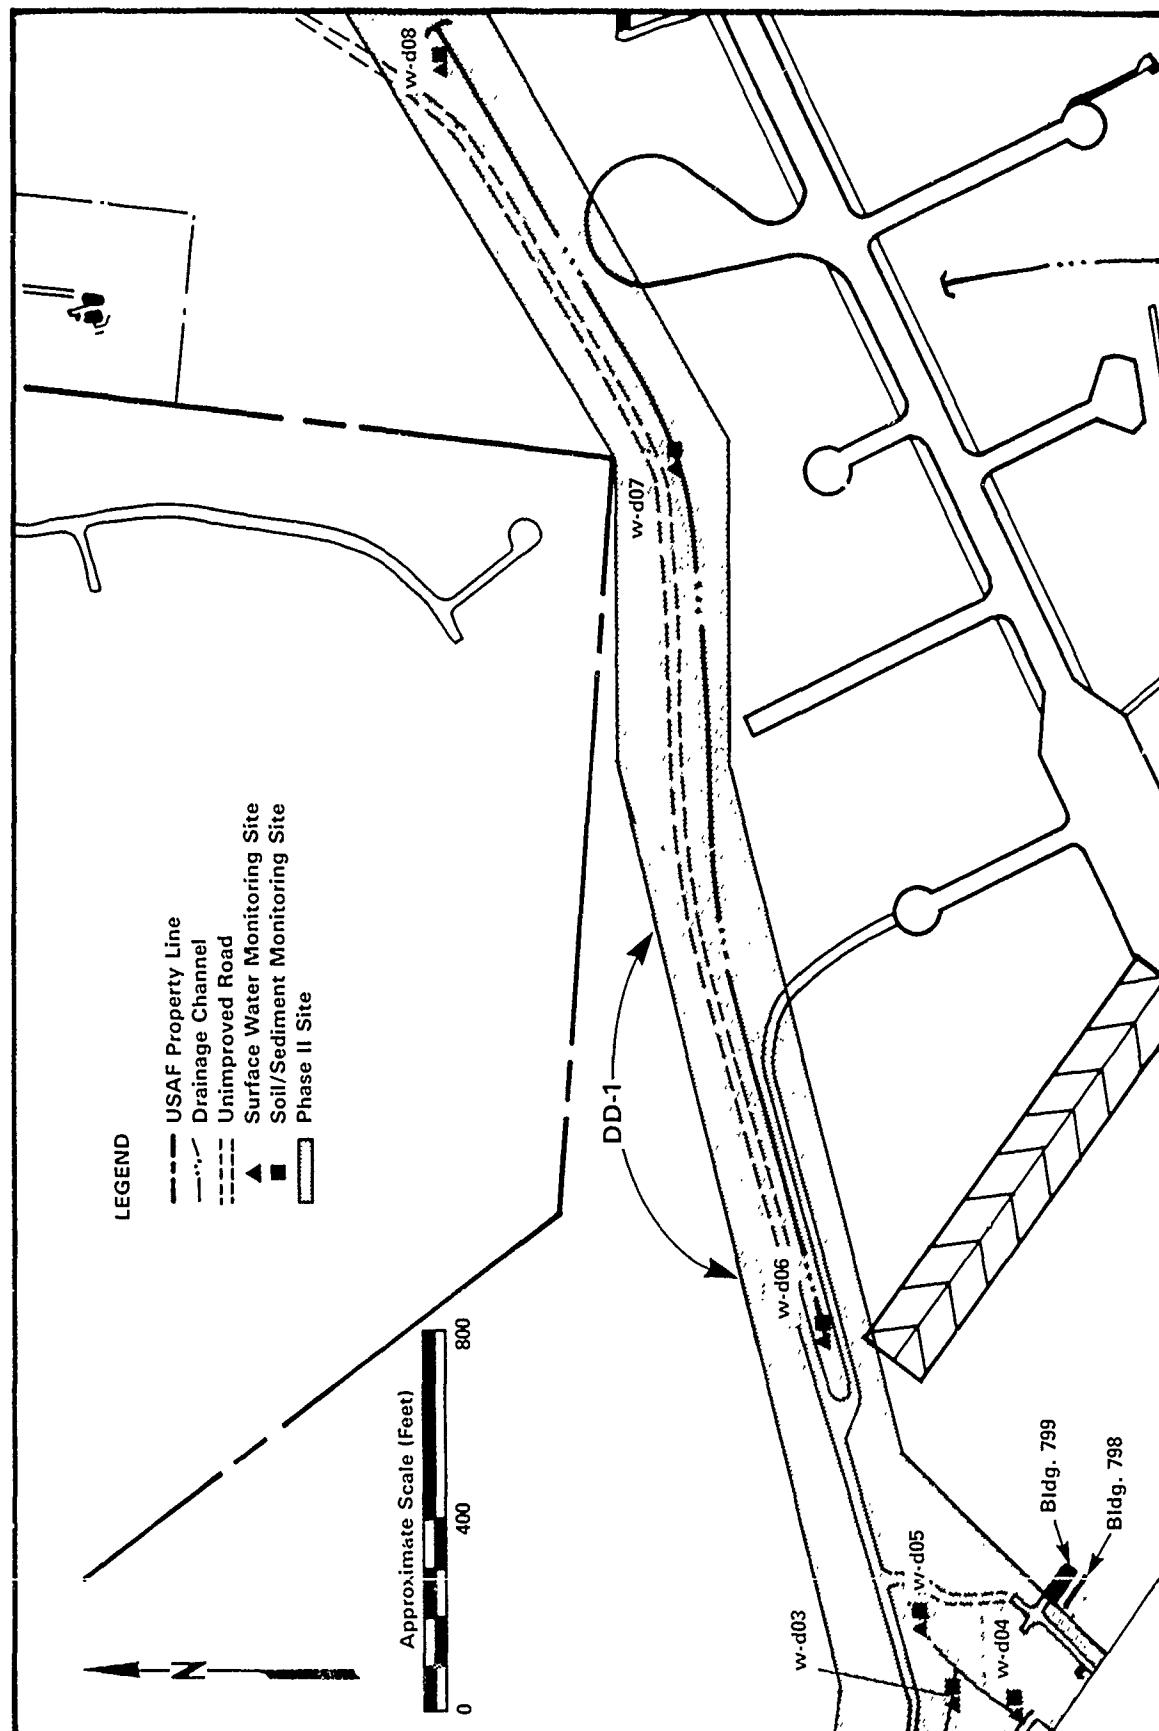
Figure 4-2. Monitoring Locations: Site DD-1, North Ditch

1. w-d03 was sited to identify impacts on water and sediment quality in the North Ditch from sites adjacent to the surface water diversion that empties to the North Ditch at w-d03 (e.g., Site XYZ).
2. w-d04 was sited at the point of wastewater discharge to the ditch.
3. w-d05 was sited at the confluence of the North Ditch and the surface water diversion mentioned in number 1 above.
4. w-d06 was sited at an outfall draining a rubble dump area north of the North Ditch.
5. w-d07 was sited at an outfall draining the runway areas.
6. w-d08 was sited at the point where the ditch narrows and flows into a large diameter concrete pipe which passes under the runway.

Samples were analyzed to determine levels of arsenic, metals, oil and grease, cyanide, phenols, TOX, and TOC. Metal analysis results for w04 are

not available because the sample was not logged into the Laboratory's QA/QC system and resampling did not take place.
